Safety Study

NYS Route 5 (Buffalo Skyway)

PIN 5134.48

August, 2020

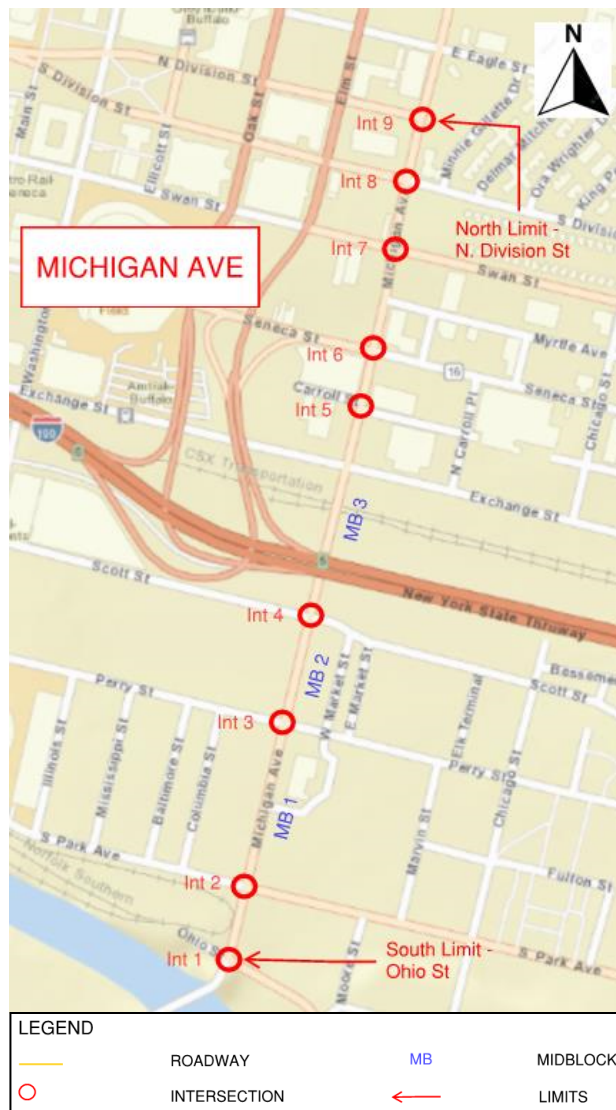
Figure 7.1.a – Michigan Avenue Location Map

Crash data was analyzed at all the midblock and intersection locations within the Project limits as shown in **Figure 7.1.a**.

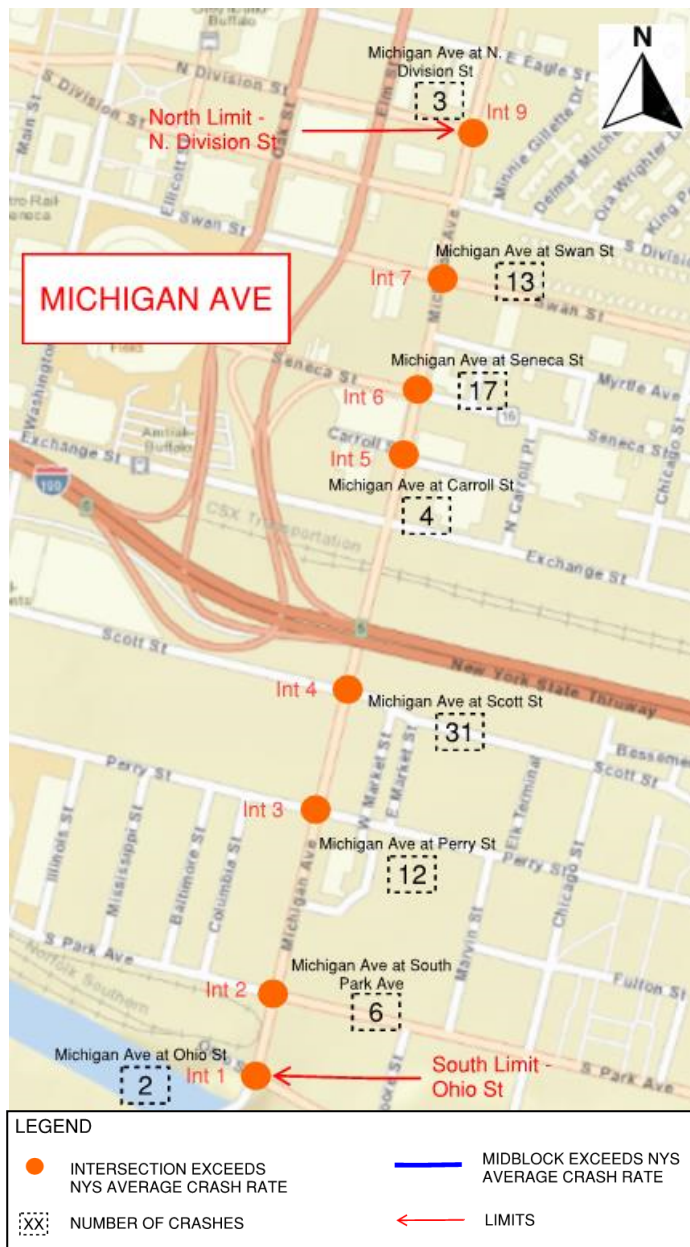
Figure 7.1.b – Michigan Avenue – Locations with Crashes Above Statewide Average Rate

Crash Rates Above Statewide Average:

- Int #1 – Michigan Avenue at Ohio Street
- Int #2 – Michigan Avenue at South Park Avenue
- Int #3 – Michigan Avenue at Perry Street
- Int #4 – Michigan Avenue at Scott Street
- Int #5 – Michigan Avenue at Carroll Street
- Int #6 – Michigan Avenue at Seneca Street
- Int #7 – Michigan Avenue at Swan Street
- Int #9 – Michigan Avenue at Division Street

Refer to section 7.2 regarding locations that exceed the statewide average rate.

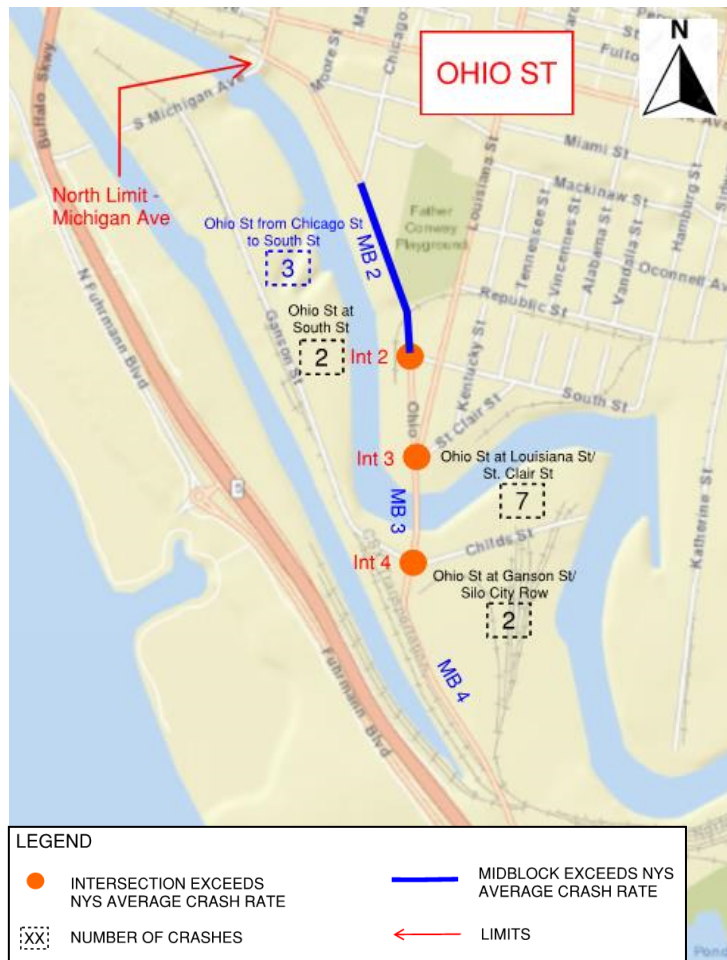
Figure 9.1.b - Ohio Street – Locations with Crashes Above Statewide Average Rate

Crash Rates Above Statewide Average:

- Int #2 – Ohio Street at South Street
- Int #3 – Ohio Street at Louisiana Street/St. Clair Street
- Int #4 – Ohio Street at Ganson Street/Silo City Row
- MB #2 – Ohio Street from Chicago Street to South Street

Refer to section 9.2 to regarding locations that exceed the statewide average rate.

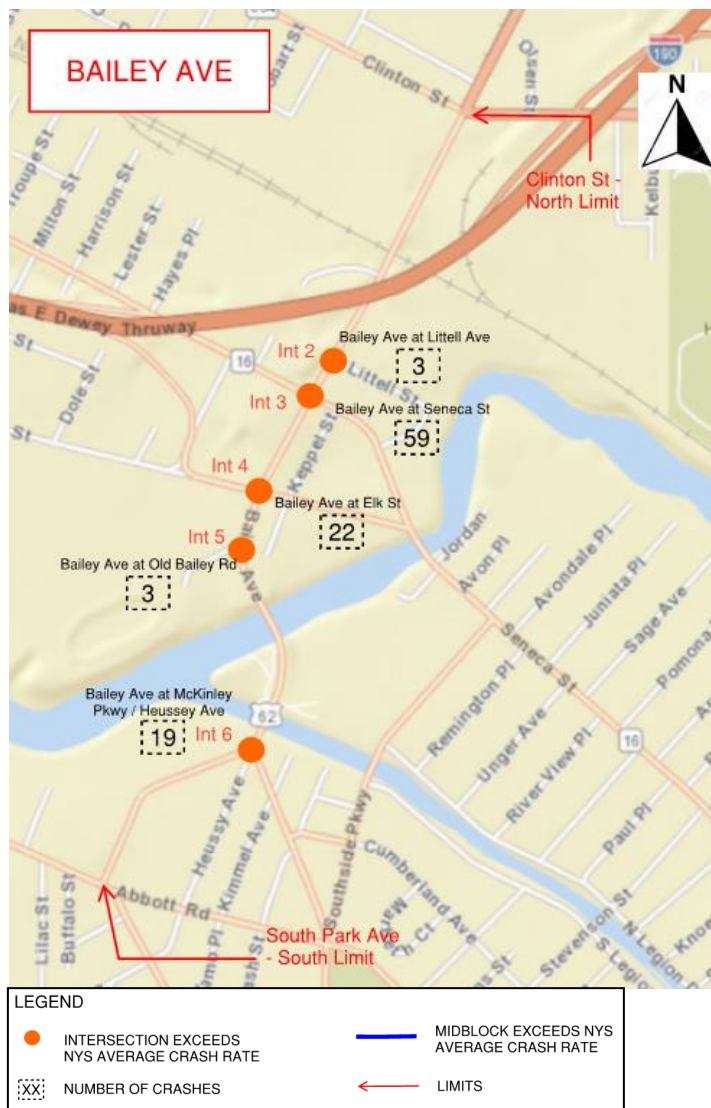
Figure 10.1.b – Bailey Avenue – Locations with Crashes Above Statewide Average Rate

Intersections with Crash Rates Higher than Statewide Average:

- Int #2 – Bailey Avenue and Littell Avenue
- Int #3 – Bailey Avenue and Seneca Street
- Int #4 – Bailey Avenue and Elk Street
- Int #5 – Bailey Avenue and Old Bailey Road
- Int #6 – Bailey Avenue and McKinley Parkway /Heussy Avenue

Refer to section 10.2 to regarding locations that exceed the statewide average rate.
